MEMORANDUM**TO: MAGIC Files****August 12, 2003****FROM: Mary P. McShane****RE: Proposed Concord-Sudbury Bikeway****1. Introduction**

This memorandum summarizes data-gathering and analysis activities performed in support of the proposed Concord-Sudbury Bikeway project, a proposed re-use of an EOTC-owned railroad right-of-way. The section currently being examined extends from Route 2 west of the Concord Rotary in Concord, to Route 20 in Sudbury, a distance of approximately 8 miles.

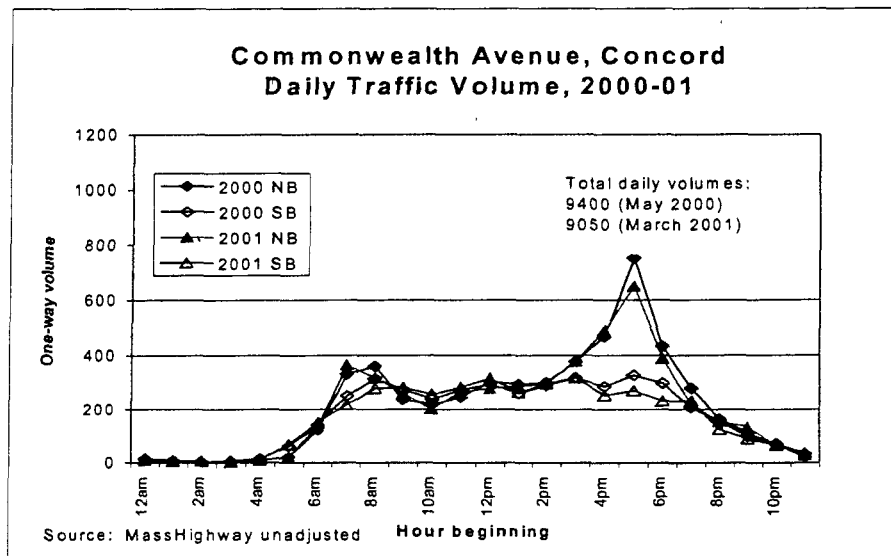
Traffic volumes: MassHighway traffic counts were performed on Commonwealth Avenue, Concord in May 2000 and March 2001. The graph below illustrates the daily variations observed during these counts: high northbound volumes are noteworthy in the evening peak hour, with a slight morning peak in the same direction; at non-peak times, volumes are fairly steady, at about 300 vehicles per hour in each direction. The total daily volume in both directions is about 9,000-9,500 vehicles.

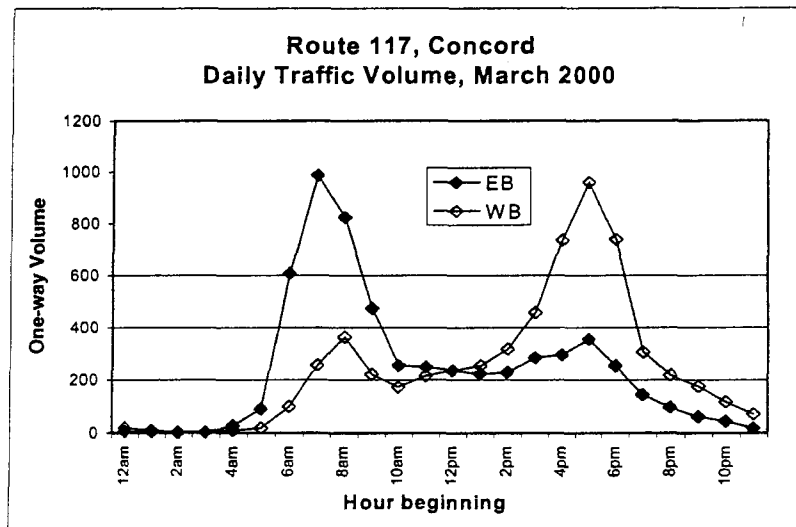
Traffic volumes: There are no counts available to us for Route 117 in Sudbury; but a MassHighway count location on Route 117 in Concord over the Sudbury River is approximately 2 miles east of the railroad right-of-way crossing. Volumes here are likely to be similar to those at the more westerly location, or possibly a bit higher. The graph below illustrates the strongly directional nature of traffic volumes on Route 117: almost 80 percent of the volume in the morning peak hour is headed eastward, while 74 percent of the evening peak hour volume is traveling west. It also illustrates that this is

predominantly a commuter route: traffic volumes fall to relatively low levels outside of peak commuting hour, and the daily peak hour (5:00 to 6:00 pm) represents 11 percent of total daily volume.² The total daily volume is about 11,700 at the Concord location.

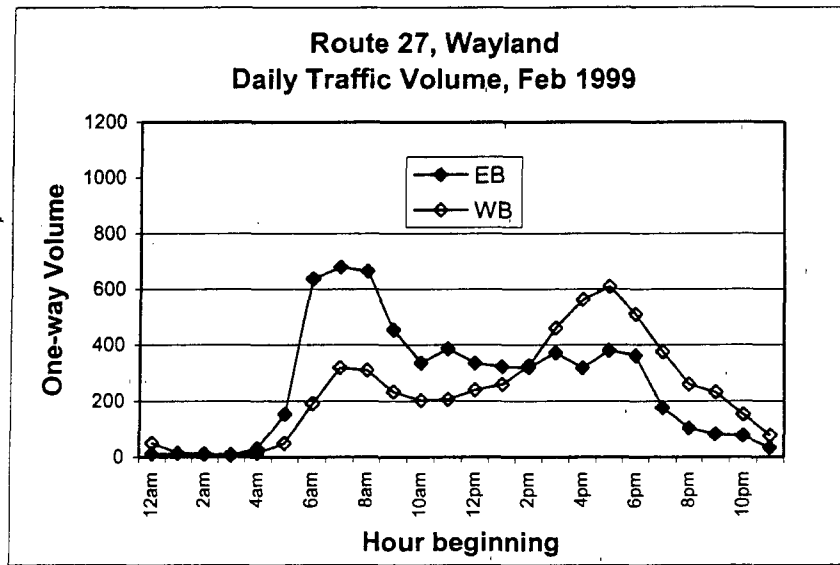
The graph below shows the daily fluctuation in weekday traffic volumes at the Wayland location. Route 27 at this location serves commuter traffic which creates noticeable peaks in the morning (eastbound direction) and evening (westbound direction). This is also true of the crossing location in Sudbury. Beyond the commuter peaks, volumes in each direction did not exceed 400 vehicles per hour in 1999.

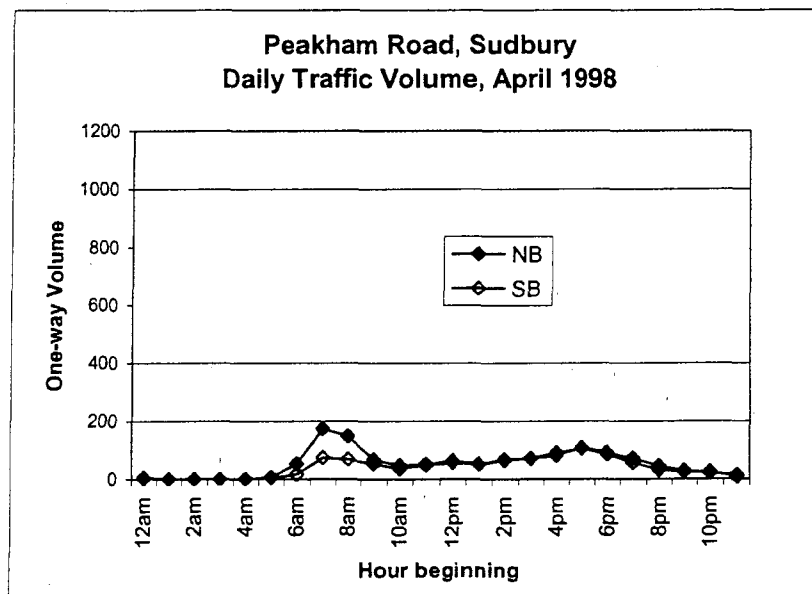
Traffic volumes: No traffic count data is available for Old Lancaster Road. However MassHighway has a count location on Peakham Road north of Austin Road, where conditions are similar to those on Old Lancaster Road. The Peakham Road location was counted in 1998 (Average Daily Traffic: 2,100) and 2001 (Average Daily Traffic: 1,500). The graph below shows the daily fluctuation in the 1998 volume: volumes stay below 200 vehicles per hour in each direction for most of the day at this location. This is most likely true of Old Lancaster Road as well.

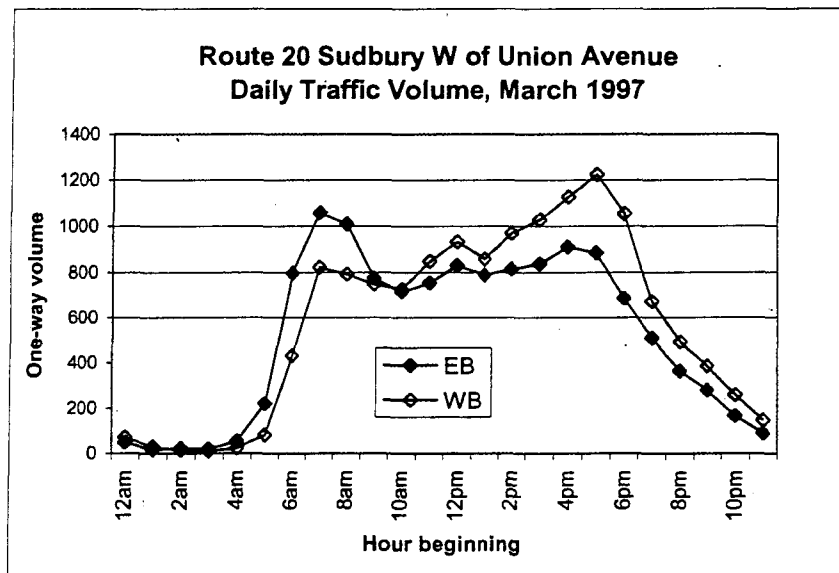
Traffic volumes: Traffic counts were performed on Route 20 in conjunction with the Functional Design Report for the installation of new signals at Nobscot Road and Union Avenue. At this location, the Average Daily Traffic (1997) was 26,400 vehicles. The graph below shows the hourly distribution of volumes at this location. As the diagram suggests, Route 20 experiences high volumes in this location relative to its capacity for a large portion of the day, not just at peak hours. This suggests the importance of Route 20 as a major arterial for general traffic, not just commuter traffic. In addition, because the right-of-way crossing is close to the Sudbury Farms shopping area and Friendly's Restaurant, it is likely that Saturday and Sunday volumes will exhibit the same sort of pattern, with chronically high traffic volumes throughout the daytime.
